# Manhole Inspection Summary

Manhole # S47A\_\_034MH

Insp Date: **8/20/08 9:40 AM**

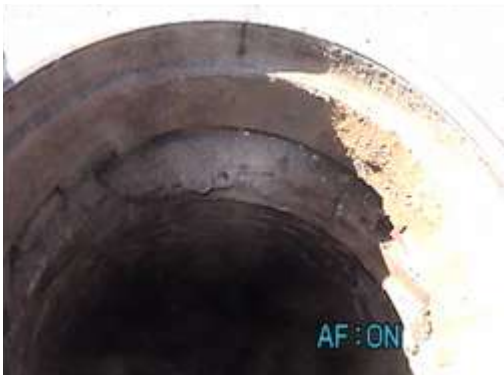
Defect 1

Infiltration: ☐ None ☐ Joint ☐ Cracks ☐ Mortar ☐ Roots ☒ **Wall**

Infiltration

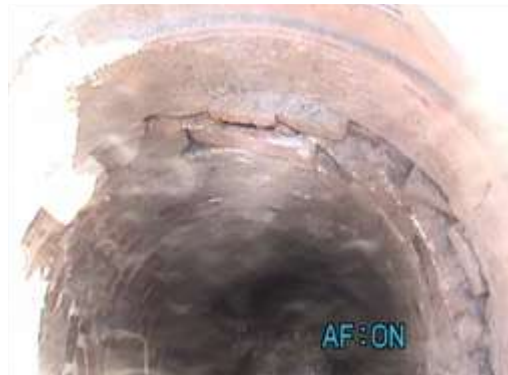
Defect 2

Condition: ☐ Sound ☐ Cracked ☐ Root Intrusion ☒ **Loose Brick** ☐ Deteriorated

Infiltration: ☐ None ☐ Joint ☐ Cracks ☒ **Mortar** ☐ Roots ☐ Wall

Loose brick

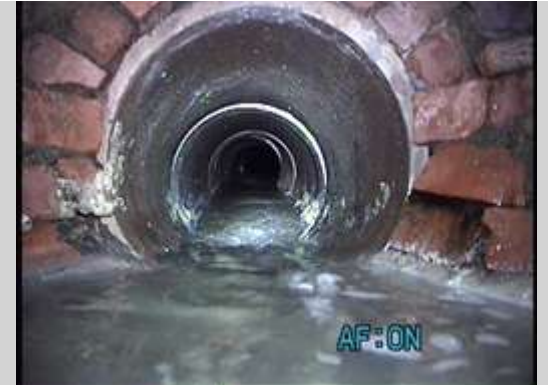
12 O'Clock Outflow

Pipe Height: **12** (in.) Rod and Bar (Angled)  
Pipe Material: **Clay** ☐ Pipe Lined  
Invert Depth: **13.30** (ft.) Flow Characteristics: **Fast**  
Deposits: ☒ None ☐ Mud ☐ Sludge ☐ Debris ☐ Grease  
Silt Depth: (in.) Deposits Extent:  
Infiltration: **None** Pipe Seal Cond: **Sound**

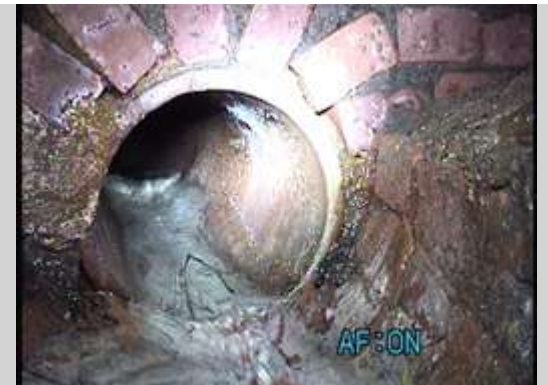
3 O'Clock Inflow

Pipe Height: **10.8** (in.) Rod and Bar (Angled)  
Pipe Material: **Clay** ☐ Pipe Lined  
Invert Depth: **13.15** (ft.) Flow Characteristics: **Fast**  
Deposits: ☒ None ☐ Mud ☐ Sludge ☐ Debris ☐ Grease  
Silt Depth: (in.) Deposits Extent:  
Infiltration: **None** Pipe Seal Cond: **Sound**

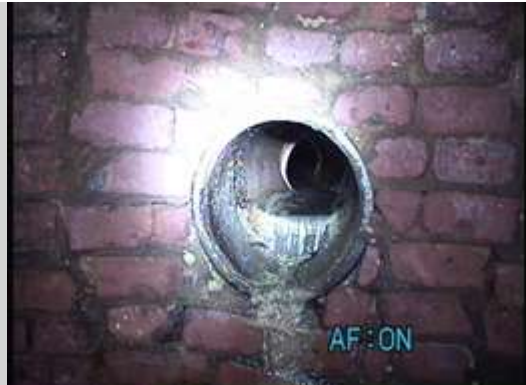
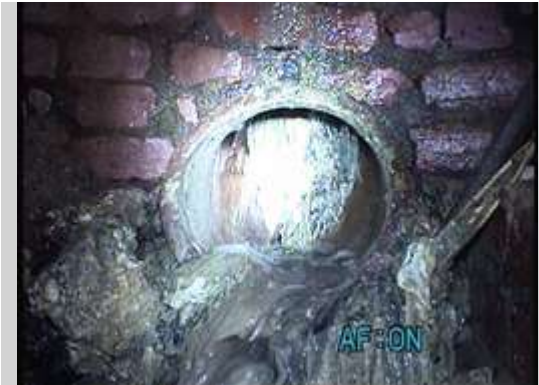
6 O'Clock Inflow

Infiltration: **None** Pipe Seal Cond: **Sound**

Drop: **Inside** Rod and Bar  
Angled: **Yes** Reading: **11.50** (ft.)  
Inv Depth: **12.50** (ft.)  
Drop Condition: **Open**

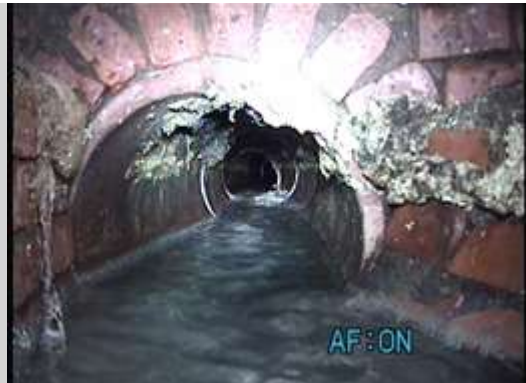
9 O'Clock Inflow

Deposits: ☐ None ☐ Mud ☐ Sludge ☐ Debris ☒ Grease

Silt Depth: **0.15** (in.) Deposits Extent: **Light**
